Note: Bridge view is looking downstream, toward the dam, or west.

Measured elevations are to the bottom of the steel in feet above sea level with the bridge unloaded and the water calm. They were measured by Bill Murdoch with a steel tape 9/13/2010.

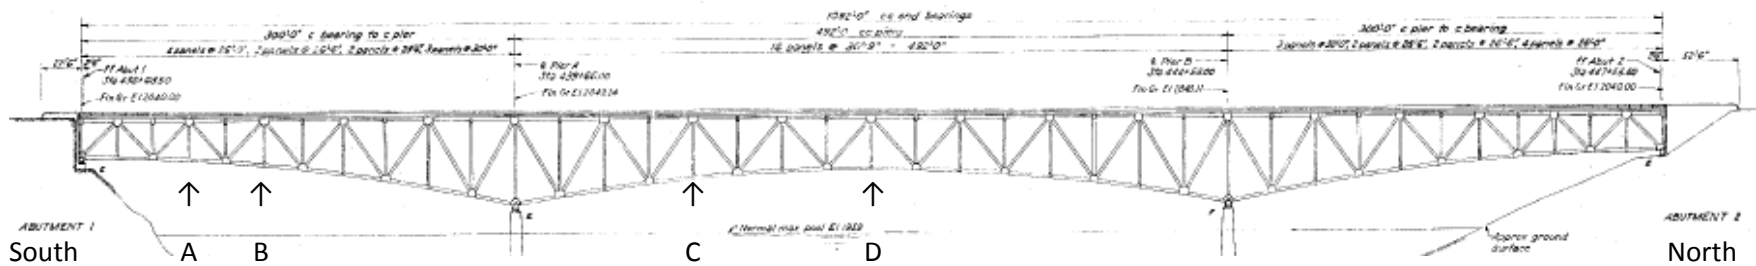
Point A (south end of 3rd panel of south span counting from south, both diagonals point upward at this point) – 2011.23'

Point B (south end of 5th panel of south span counting from the south, both diagonals point upward at this point) – 2007.39'

Point C (south end of 4th panel of center span counting from south, both diagonals point upward at this point) – 1997.35'

Point D (center of span, both diagonals point up at this point, TVA reports 2002', Tennessee DOT reports 2000') – 2003.35'

For clearance subtract the lake elevation as reported by TVA (800-238-2264, then press 1 for lake levels, then 02 for Watauga Lake).

There are white painted marks on both sides of the south bridge pier showing the water elevation with a clearance of 50.2' under the south span.
